Geochempet Services

PETROGRAPHIC REPORT ON A SAND SAMPLE (TYN18S-00587) FROM TYNONG QUARRY

**FULTON HOGAN
TYNONG, VIC**

Sample Number: TYN18S-00587 **Date Sampled:** 01/03/2018

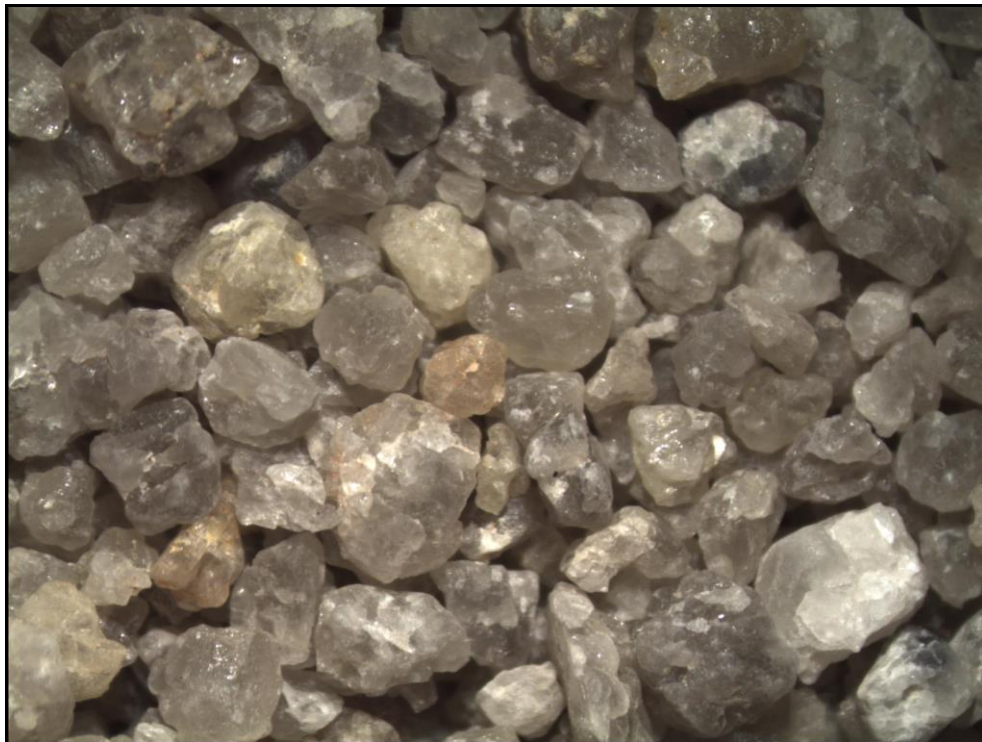
Figure 3: Digital image of sieve fractions recorded above.

Sieve Size	Wt % of sample
Coarse (>1.18mm)	40.6%
Medium (>0.3mm)	42.0%
Fine (>0.075mm)	16.6%
Silt (<0.075mm)	0.8%

Clasts range up to 4mm. The coarse fraction consisted of mainly quartz grains, minor lithic fragments. A subsample swirled with water in a beaker generated little or no turbidity indicating minor silt and free clay present.
